HYDROLATOR

ZERO DISCHARGE APPLICATION FOR POWER PLANTS

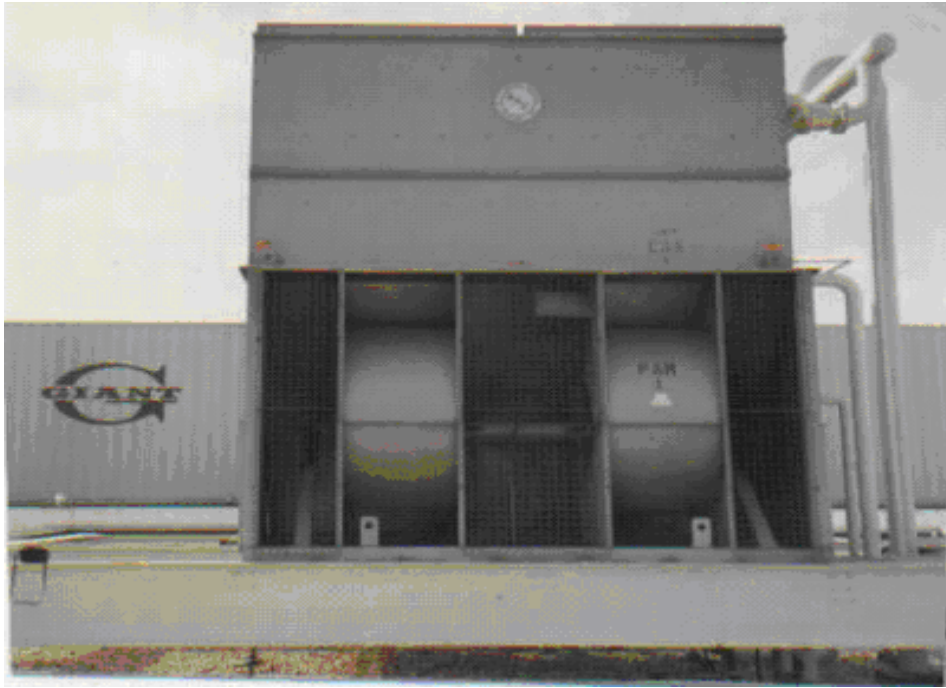
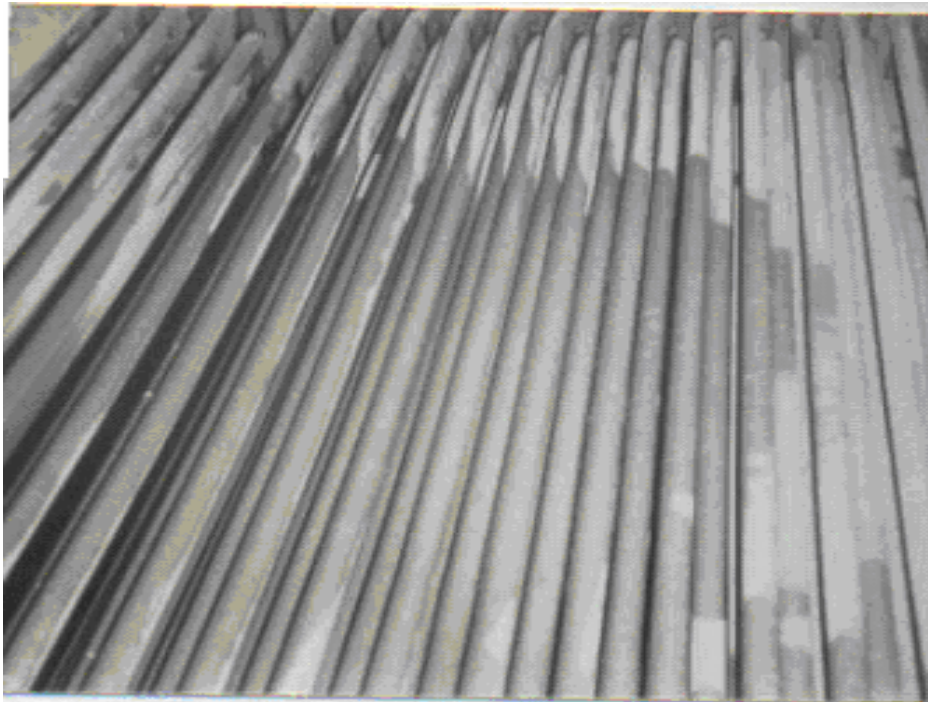
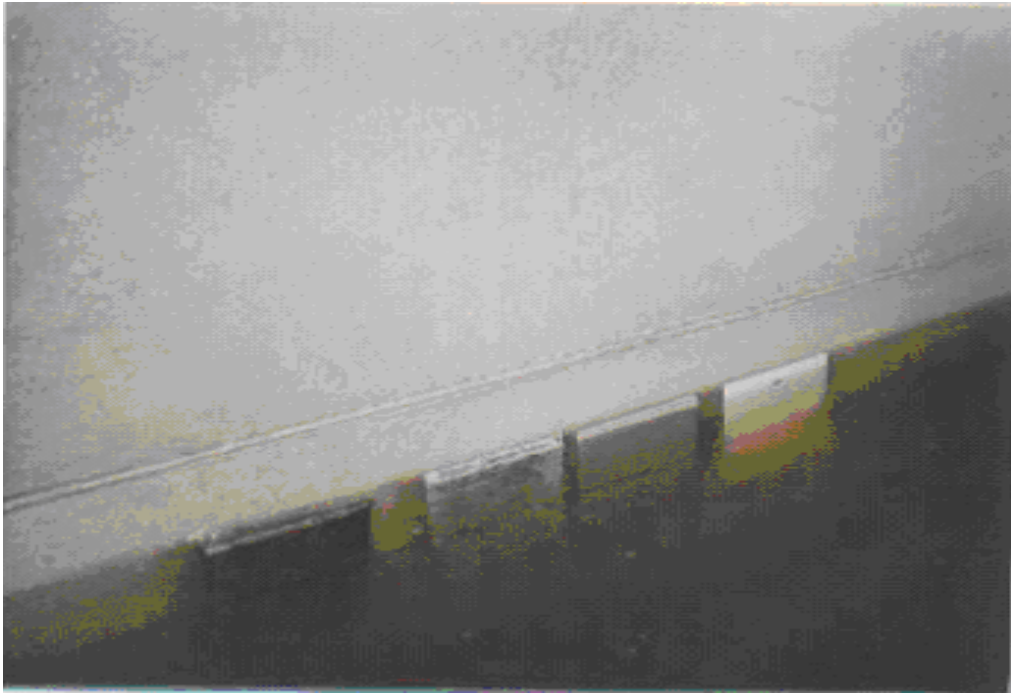
No scale formed during the test and no corrosion was detected. The steel tubes shown were clean. Where the tubes in the photos are dry a fine white talc of aragonite is visible clinging to the bare surfaces. This layer is a microns thick nucleation, which we believe improves the heat transfer through micro-turbulence at the water/metal junction. This may explain, in part why heat transfer is dramatically improved. For example, Dave Saul (see BSC reports) had to reduce sea-water cooling to his spiral coolers, because of over-cooling of the ammonia liquor which cools and quenches the coke oven gas. In addition, surface tension (or inter-molecular attraction) is eliminated in HYDROLATOR charged water, this has been seen in many still-water vessels (swimming pools, cooling towers) where one cannot visually detect the water surface without disturbing it. In Dave Saul's and other closely monitored applications, up to 25% reduction in coolant flow or energy use have been reported.

In 1988, HYDROLATOR installed a test system in one of two identical small DX closed coolers (shown) which cool the 200° F compressed Freon gas for ice-cream production at Giant Foods in Jessup, MD. Scale was prevalent and operating temperatures high. One of the goals of the test were to prove HYDROLATOR de-scaling performance and to monitor the effects of zero discharge on the system. That is, the bleed-off or blow-down from the cooler was turned off. Within a month, all deposits were cleaned from tube surfaces and water turned crystal clear, indicating normal HYDROLATOR function. A further goal was to monitor corrosion by placement of metal specimens at the water margin, consisting of (from left to right) mild steel, galvanized, stainless steel and epoxy-coated samples. As cycling up proceeded from 3-5 cycle start, the water increased in turbidity to maximum (limited by windrift) concentration of 100 cycles, 20,000 micro mhos, 6000+ PPM of calcium hardness and 7000+ PPM of chlorides. The test period was 1 ½ years. During dry spells, a white deposit could be seen from the roof around the perimeter of the cooler.

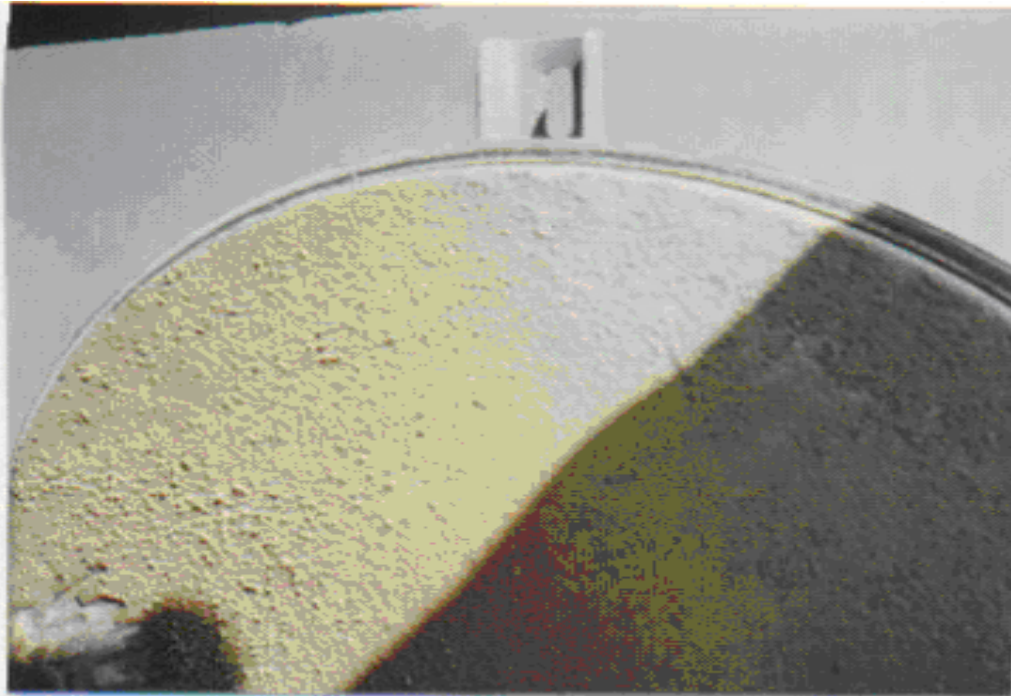
This closed cooler test proved also that in a HYDROLATOR controlled system, solubility actually increases with temperature. The coolest part of the cooler turned out to be the access door. And, it was on this door that soft, large, nearly transparent crystals formed at saturation on the surface (see photo) while the hot tubes remained clean. For further information and demonstration call Ted Light at (410) 352-5524
